PARSONS TECHNICAL MEMORANDUM

SUBJECT: Pyramid Way and McCarran Boulevard Intersection Improvement Project
Draft EIS – Hazardous Waste and Materials
FHWA-NV-EIS-12-01-D
RTC Project No. 73299
Federal Project No. CM-0191-(063)

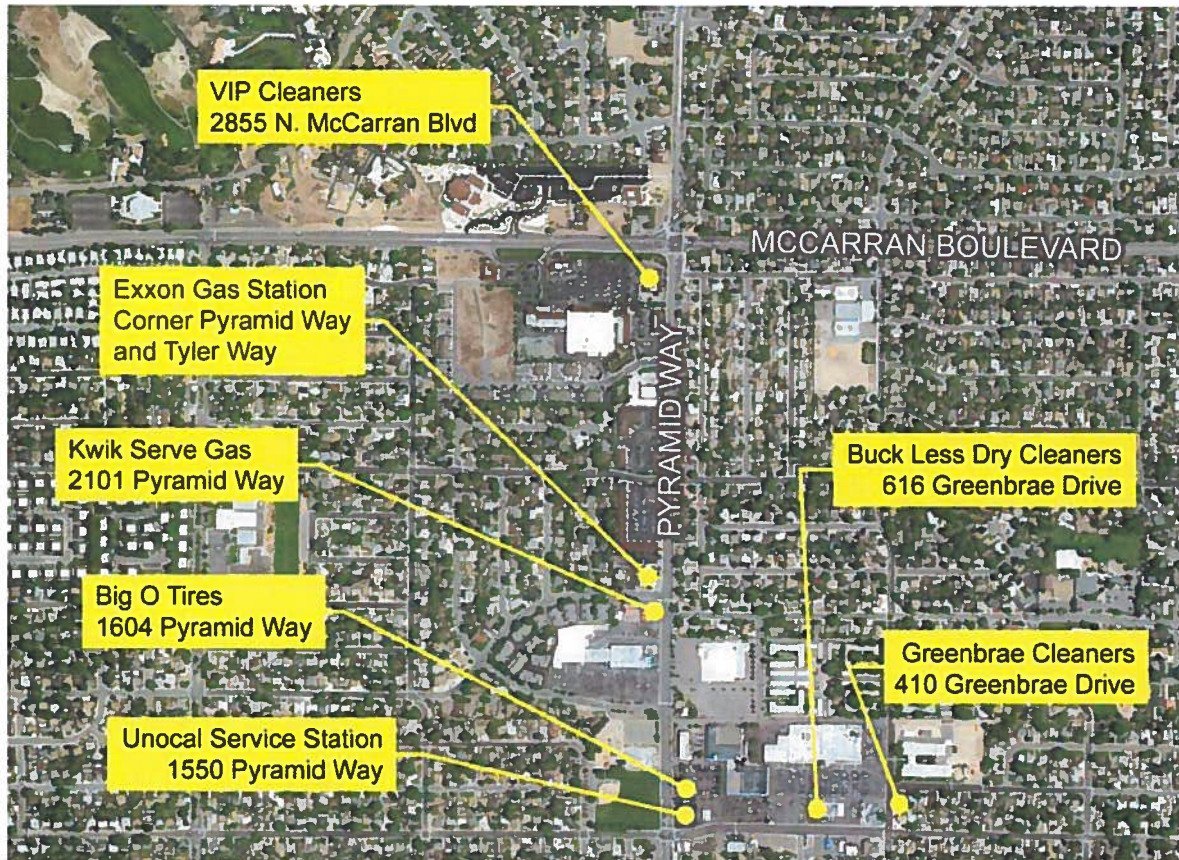
Seven of the eight identified active hazardous material sites within 1-mile of the project boundaries are identified in Figure 1. The State site under investigation described above, which is located at 1629 G Street, is not within coverage of the aerial photograph.

Figure 1 Active Hazardous Material Sites within the Proposed Project Boundaries
